**HISTORIC RESOURCES INVENTORY
BUILDING AND STRUCTURES**

IDENTIFICATION	1. BUILDING NAME (Common) _____ (Historic) <u>Newton, John B., House</u>	
	2 TOWN CITY <u>Durham</u>	VILLAGE _____ COUNTY <u>Middlesex</u>
	3 STREET AND NUMBER (and or location) <u>Maiden Lane, south side, .1 m east of Main Street</u>	
	4 OWNER(S) <u>Wayne and Brenda Hannen</u> <input type="checkbox"/> Public <input checked="" type="checkbox"/> Private	
	5 USE (Present) _____ (Historic) <u>Residence</u>	
	6 ACCESSIBILITY TO PUBLIC: <input checked="" type="checkbox"/> Yes <input type="checkbox"/> No INTERIOR ACCESSIBLE <input type="checkbox"/> Yes <input checked="" type="checkbox"/> No IF YES EXPLAIN _____	
DESCRIPTION	7 STYLE OF BUILDING <u>Nineteenth-century Domestic</u> DATE OF CONSTRUCTION <u>1861</u>	
	8 MATERIAL(S) (indicate use or location when appropriate)	
	<input checked="" type="checkbox"/> Clapboard <input type="checkbox"/> Asbestos Siding <input type="checkbox"/> Brick <input type="checkbox"/> Other (Specify) _____ <input type="checkbox"/> Wood Shingle <input type="checkbox"/> Asphalt Siding <input type="checkbox"/> Fieldstone <input type="checkbox"/> Board & Batten <input type="checkbox"/> Stucco

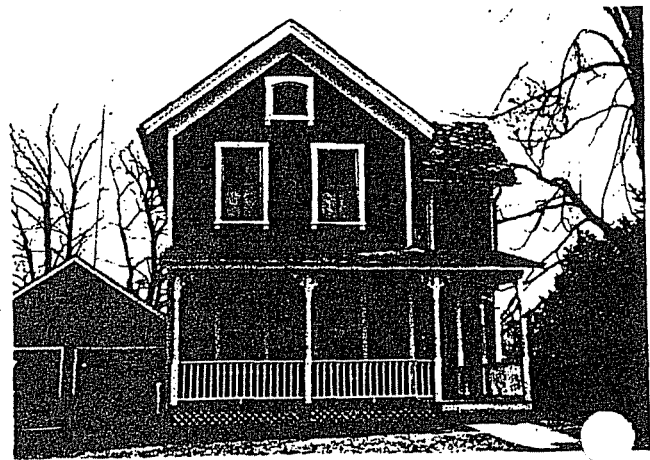
This house possesses an Eastlake-style single-story porch on its north and west sides, composed of turned and sawn elements. The balustrade, however, is a recent replacement. The fenestration in the facade is two-over-two except for the single window in the gable peak, which contains a two-paned fixed window with an arch top. A small (9 x 19) shed-roofed addition has been added to the rear of the house. This adjoins with a two-car garage of recent origins.

The John B. Newton House is a 2½ story, cross-gabled residence in the nineteenth-century Domestic style. The clapboarded balloon frame rests on a sandstone foundation. The roof is asphalt-shingled.
