**HISTORIC RESOURCES INVENTORY**  
**BUILDING AND STRUCTURES**  
 HIST-6 NEW 5 77

IDENTIFICATION	1. BUILDING NAME (Common) <span style="float: right;">(Historic)</span> Curtis, John, House	
	2. TOWN CITY Durham	VILLAGE Middlesex
	3. STREET AND NUMBER (and or location) Brick Lane, east side

THE JOHN CURTIS HOUSE, Brick Lane, Durham

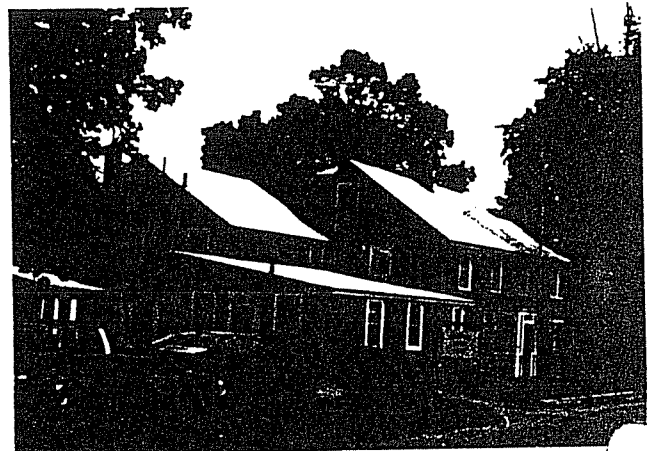
PHOTO	PHOTOGRAPHER P.D. Hall		DATE 6/83
	VIEW Southeast	NEGATIVE ON FILE 5:26	
COMPILED BY	NAME E.R. Hart		DATE 11/83
	ORGANIZATION Greater Middletown Preservation Trust		
	ADDRESS 27 Washington St., Middletown, Conn. 06457

Additions include a 2½ story, single-bay, ridge-to-street ell added to the south elevation giving the facade a four-bay appearance. A 2½ story, ridge-to-street ell has been added to the rear portion of the north elevation and a single story, two-bay shed-roofed ell has been added to the front portion of the same elevation. Another large, single story ell has been added to the eastern elevation. All the additions are supported by concrete foundations. The facade entryway is concealed by a small, single-bay, single story enclosed entry porch which features an eight-paned glass door flanked by two long single-paned sidelights and surmounted by a two-paned overlight. A small decorative dentil course trims the eaves of the porch. Six-over-six and six-over-one sash are exhibited throughout the house. (cont)

This 2½ story, three-bay, center-chimney Colonial-period house has been significantly altered since it was erected by John Curtis ca. 1770. Capped with a ridge-to-street gable roof, the original block utilizes a post-and-beam framing system which rests on a sandstone foundation. The major alterations to the building are the many twentieth-century, balloon-framed additions that have been superimposed on the north, east and south elevations when the building was enlarged as a convalescent home. The entire house is asbestos-sided and all the roofs are asphalt-shingled.
